**NATIONAL PERFORMANCE AUDIT PROGRAM (NPAP)  
THROUGH THE PROBE PERFORMANCE AUDITS  
OF  
AMBIENT AIR MONITORING STATIONS IN PUERTO RICO  
OPERATED BY  
PUERTO RICO ENVIRONMENTAL QUALITY BOARD  
(PREQB)**

**JULY 12-14, 2016**

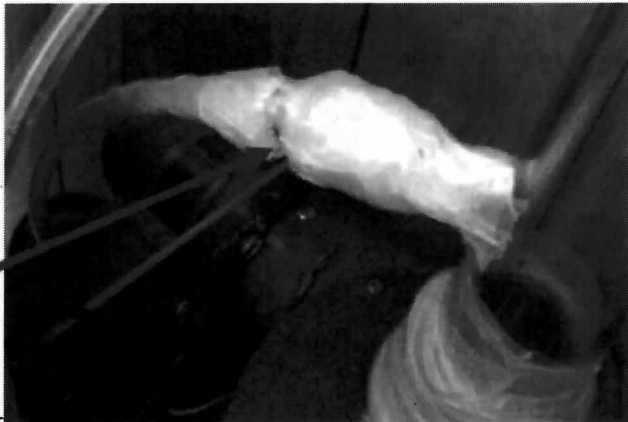
Table 1 below, shows the audit results at the Bayamon-Las Vegas site. The site met EPA siting criteria. The SO<sub>2</sub> instrument failed EPA audit criteria with a bias >15%. Investigation by EPA revealed that the analyzer line was attached to the

sampling manifold using paraffin film, which was cracked. There was also no ferrule in the manifold connection. This resulted in a leak. (See picture 1, below)

Picture 1. Cataño-Las Vegas Site, showing parafilm for sealing analyzer to manifold.

Broken seal and leak in SO2 analyzer line.

The station gas standard for SO<sub>2</sub> was plumbed with a brass nut and ferrule, instead of the stainless steel required for reactive gases, and is shown in Picture 3, below. The paraffin film for the SO<sub>2</sub> manifold was replaced with Teflon tape by EPA, as a temporary fix (Picture 4).

**Recommended Corrective Action:** Replacement of all non-compliant manifold connections at the site, and network-wide.

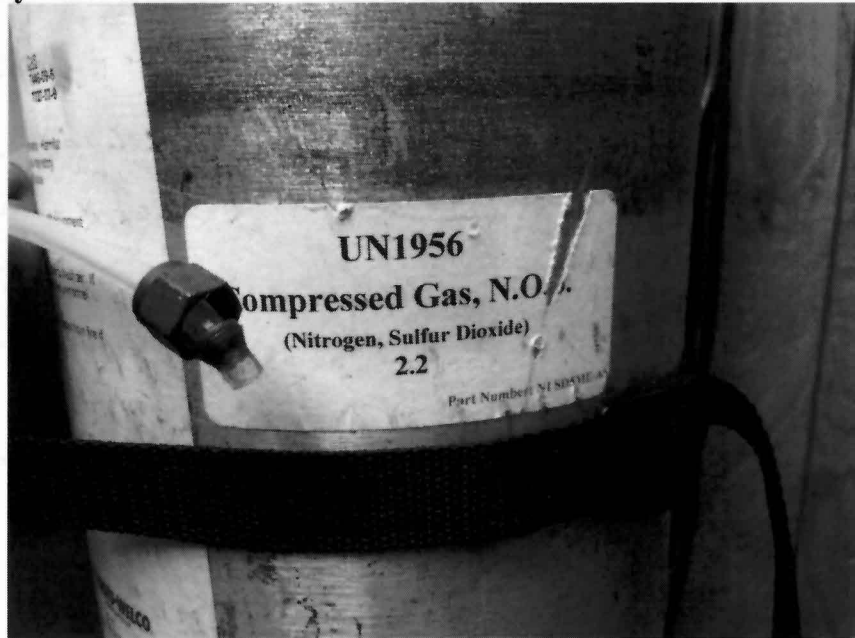
**Picture 3. Cataño-Las Vegas Site, showing brass ferrules and nuts in use with NOx standards cylinder.**

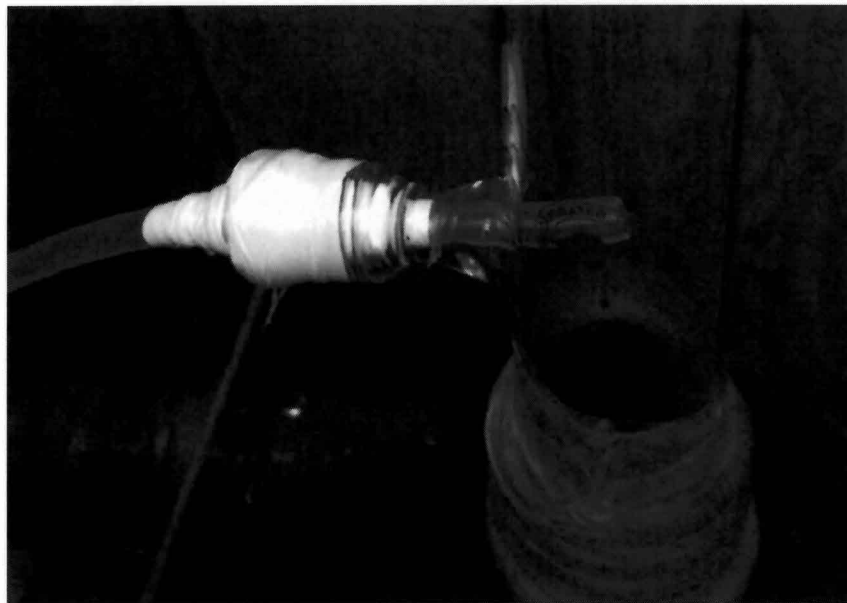
**Picture 4. Cataño-Las Vegas Site, showing replacement of parafilm with Teflon tape**

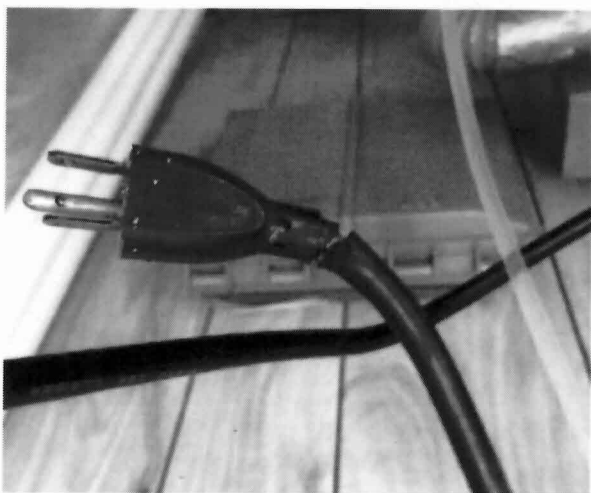
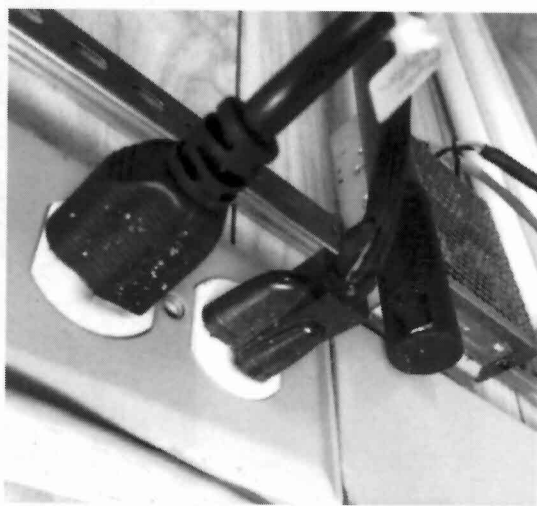
The Salinas audit results are presented in Table 2 below. The site met siting criteria and EPA audit criteria. Pictures 5 and 6 below, show frayed and worn electrical cords at the site that present a potential fire and electrical shock hazard and should be replaced immediately. EQB staff was notified and shown the hazard at the time of the audit.

Picture 5 and 6 – Electrical hazards at Salinas site.

Electrical hazards, such as the frayed power cords seen at Salinas, must be replaced to avoid potential electrical hazards.

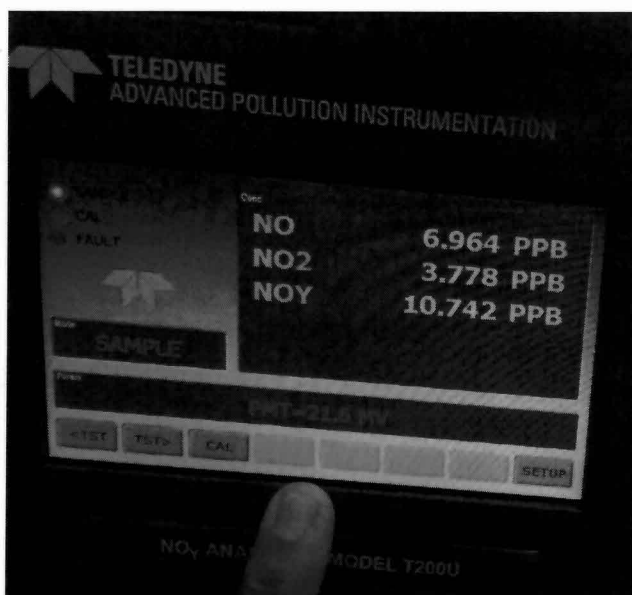
**NO<sub>y</sub> analyzer:** The analyzer was on and responsive to commands, and menus were operational. Low operational PMT voltages were observed during sampling (Picture 8). A PMT diagnostic test was run and failed (picture 9), indicating at least one source of the operational status of the instrument.

Picture 8. Bayamon NCore Station - NOy Analyzer PMT value while sampling.

**Recommended Corrective Action:** NO<sub>y</sub>, SO<sub>2</sub> and CO analyzers at the NCore station at Bayamon must be repaired, calibrated, and maintained.

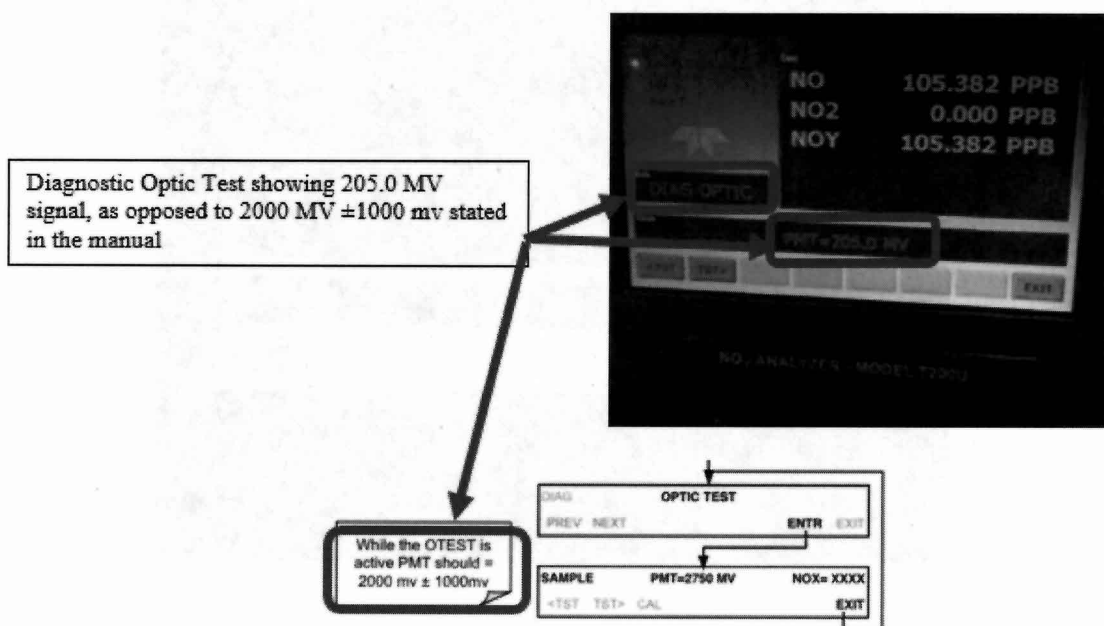
Picture 9. Bayamon NCore Station - NOy Analyzer PMT value and expectations from analyzer manual

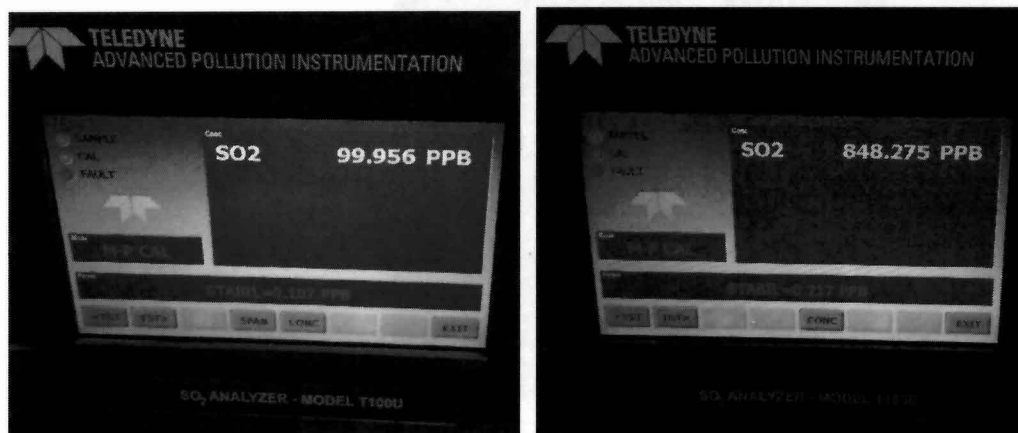
**SO<sub>2</sub> Analyzer:** The analyzer was on and responsive to commands, and menus were operational. Analyzer response to zero gas was 99.956 ppb SO<sub>2</sub>, and to 47.8 ppb audit gas was 848.275 (Pictures 10 and 11). Recalibration of the instrument was not possible, because the instrument zero was too far out of range and locked out by the firmware

**Picture 10 and 11. Bayamon NCore Station - SO<sub>2</sub> analyzer response to EPA zero gas, and 47.8 ppb SO<sub>2</sub>**

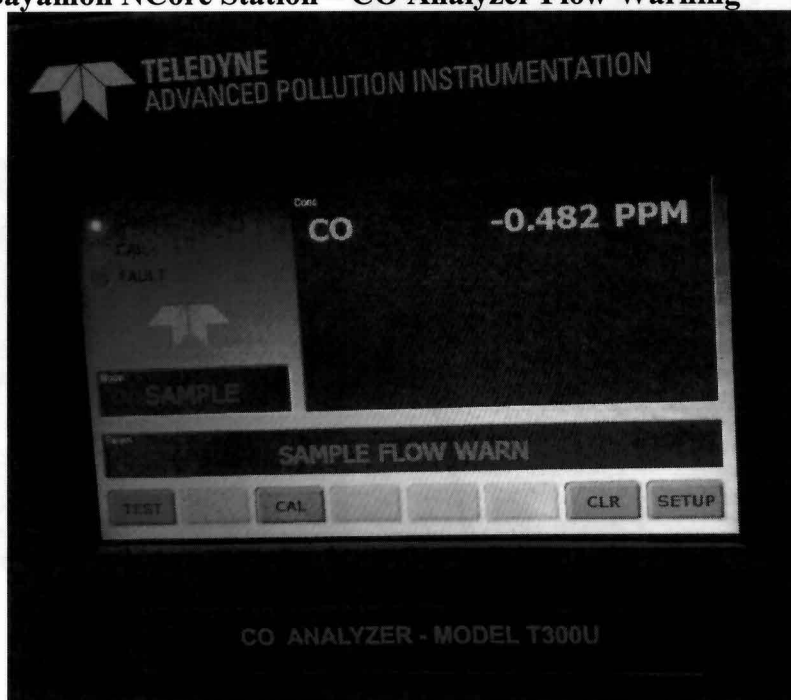
**CO Analyzer:** The analyzer was on and responsive to commands, and menus were operational. A flow warning was flashing on the screen (picture 12). Flow troubleshooting was not attempted.

**Picture 12. Bayamon NCore Station – CO Analyzer Flow Warning**
